Technical Evaluation of the Gold King Mine Incident

San Juan County, Colorado

U.S. Department of the Interior
Bureau of Reclamation
Technical Service Center
Denver, Colorado

October 2015

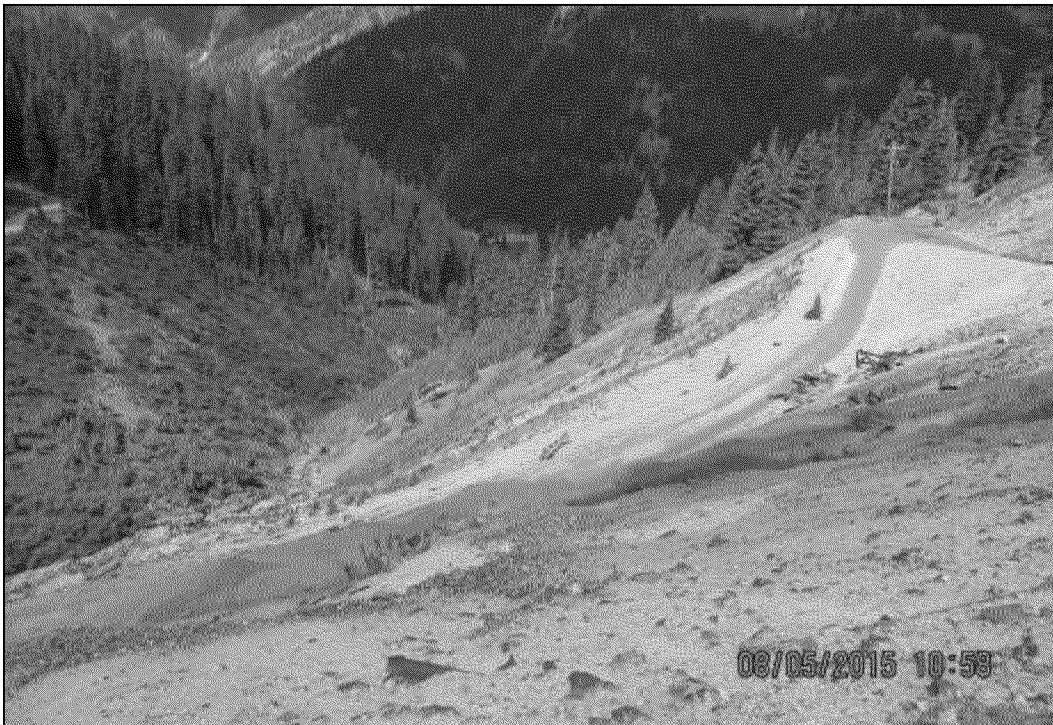
Figure 57.—Photograph showing a portion of the mine water flowing down the access road at 10:58 a.m. on August 5, 2015 (photograph from EPA project files).
